Phase I Desk Study Report

Title	Phase I Desk Study Report
Client	Romo Holdings Ltd
Location	Land South of A617, Rainworth
Project number	18-0494
BIM reference	RAIN-BSP-ZZ-XX-RP-G-0001-P01_Phase_1_Site_Investigation
Date	23rd December 2020

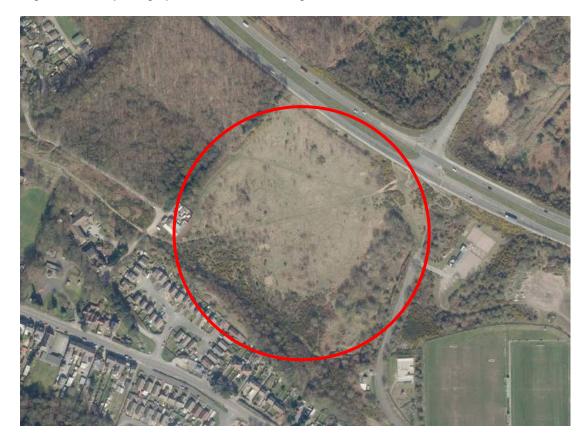
Figure 1: Aerial photograph of the site (2020 image).

An aerial photograph of the site, obtained from the Landmark Analysis tool commissioned as part of our works, is presented in Figure 1 below.

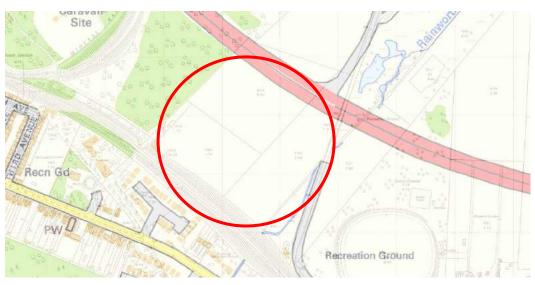
Figure 3: 1999 Aerial Image

Figure 3 shows an aerial image of the site in 1999, showing the majority of the site as agricultural land, prior to the construction of the A617 to the sites north.
